MISCELLANEOUS PAPER GL-79-4

## EVALUATION OF THE EFFECTIVENESS OF MEMBRANES FOR PREVENTION OF CRACK REFLECTION IN THIN OVERLAYS

March 1979

Interim Report

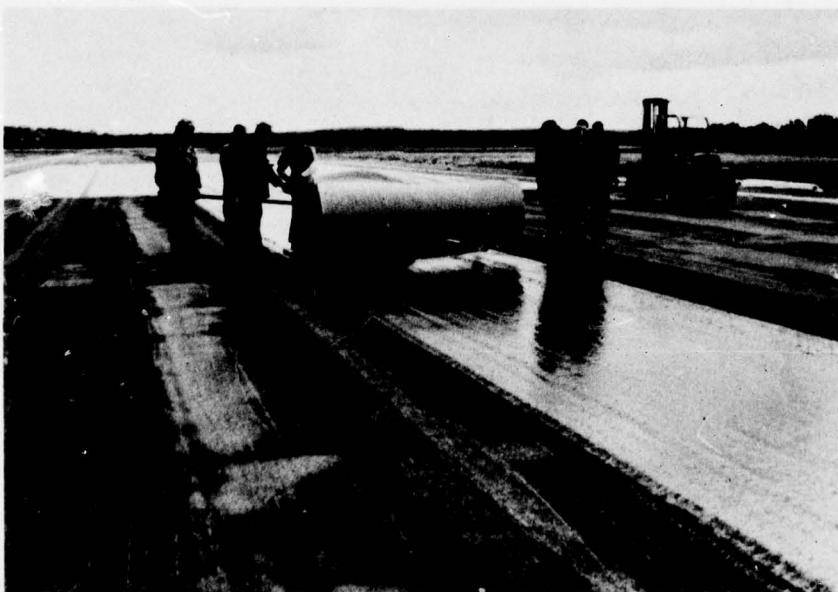
Photo 4. Fort Devens--placement of Bidim C-22 fabric on NW-SE runway; very difficult to place wrinkle free

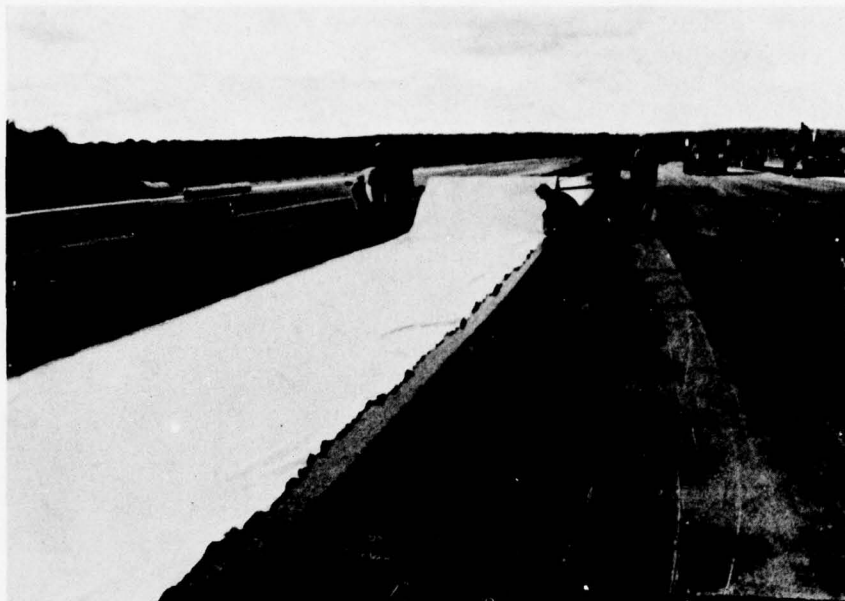
Photo 5. Fort Devens--sawed edge of Bidim C-22 gave a ragged appearance; material smoothed out under roller

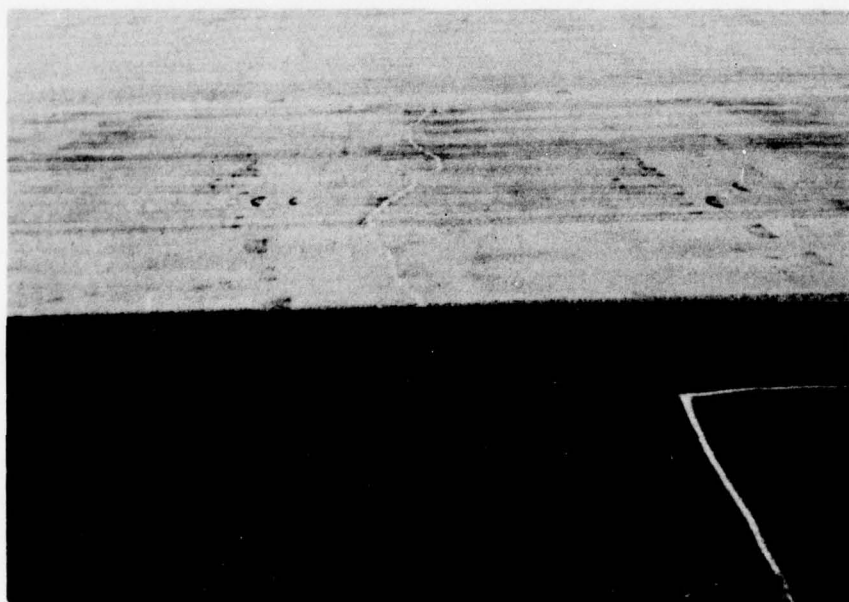
Photo 12. Fort Devens--unsealed crack under Bidim C-22 fabric in apron test area

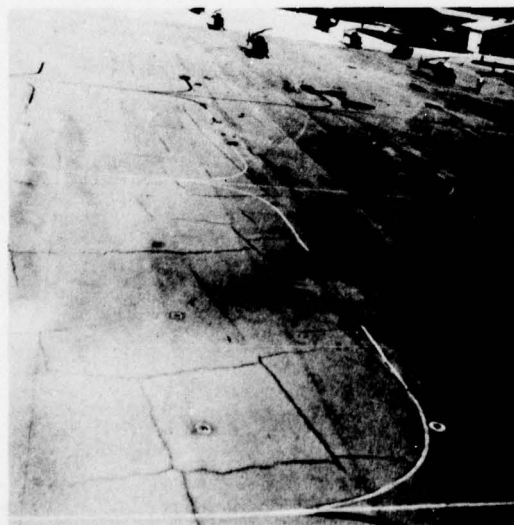
Photo 20. Fort Stewart--crack pattern  
from soil-cement base

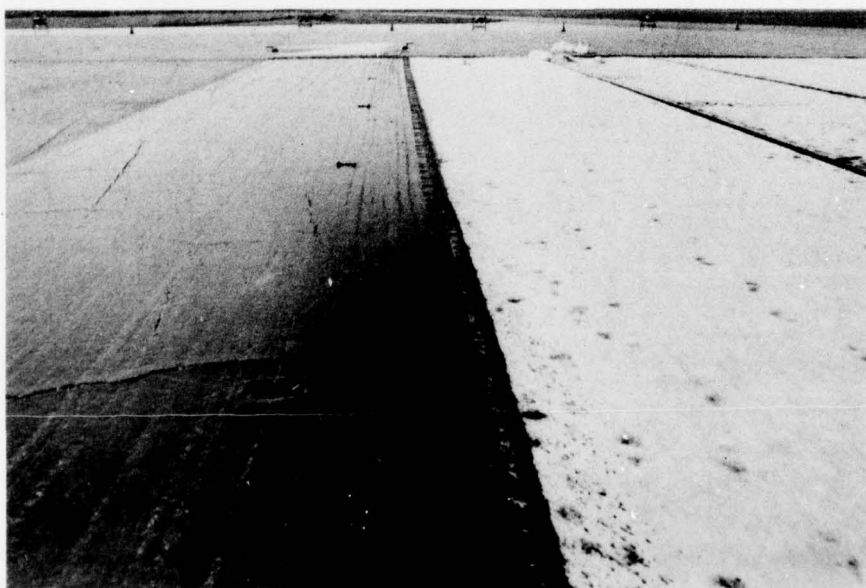
Photo 22. Fort Stewart--overlap of about 6 in.;  
note wrinkling of Mirafi 140 fabric

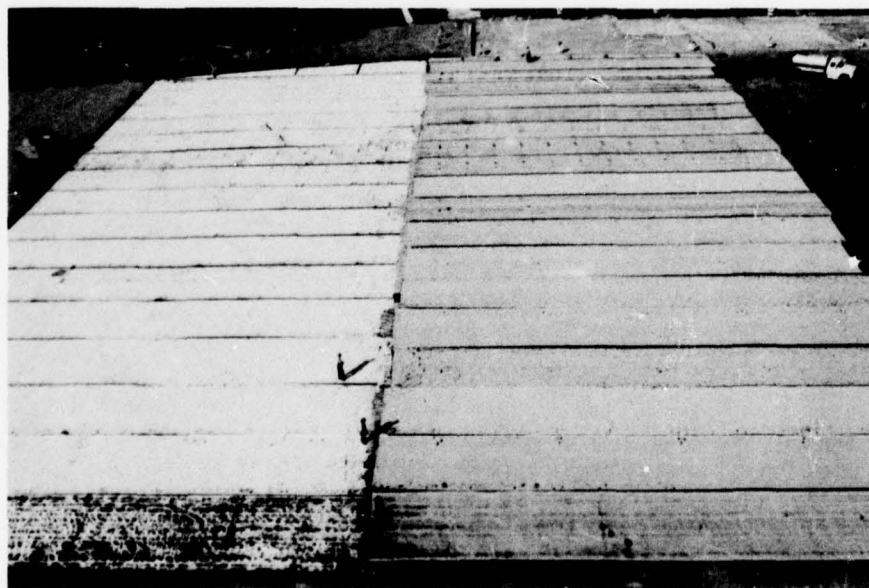
Photo 24. Fabric sections installed; joint between sections sanded to prevent roller pickup; lane in foreground where fabric was placed before emulsion allowed to cure; Mirafi 140 fabric on left and Bidim C-22 fabric on right

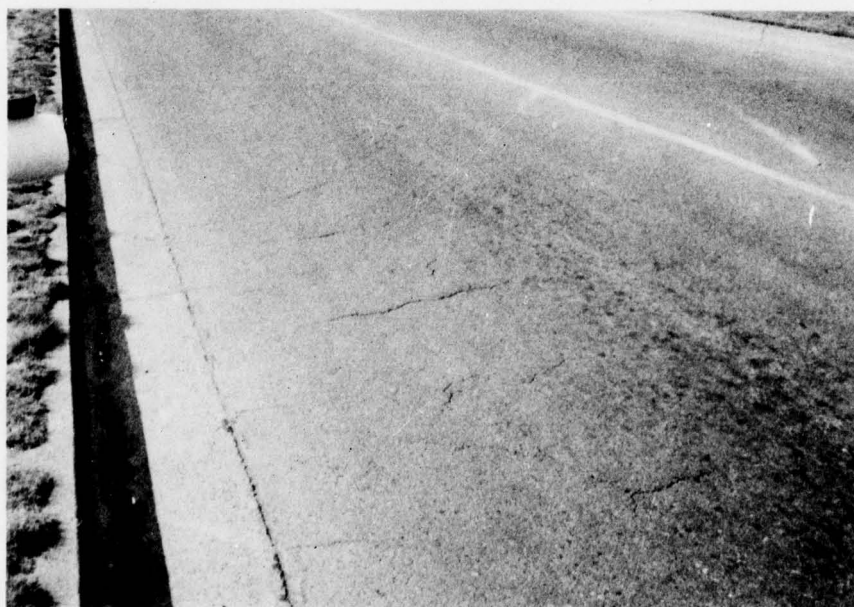
Photo 30. Fort Lewis--type cracking in pavement  
surface on Second Division Drive

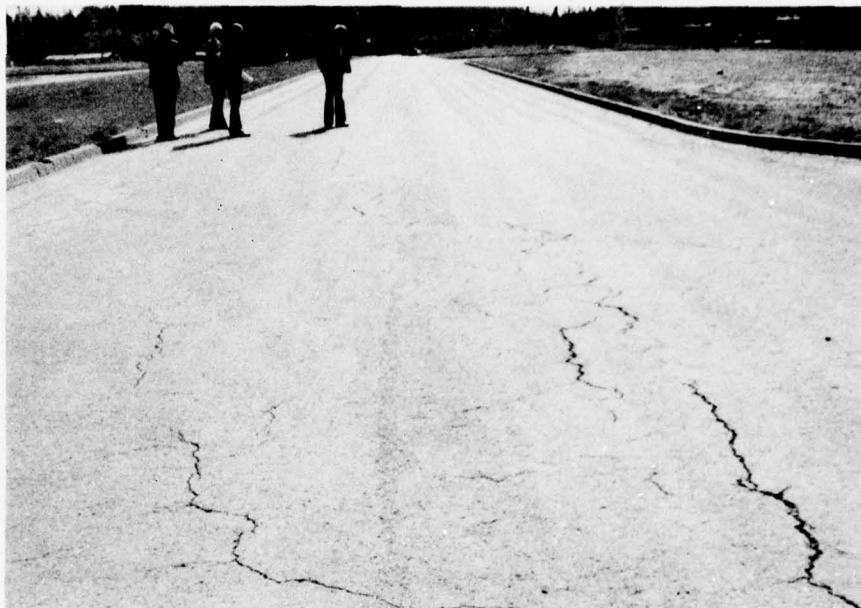
Photo 31. Fort Lewis--cracking in pavements on Faith Avenue; most of cracks in localized areas

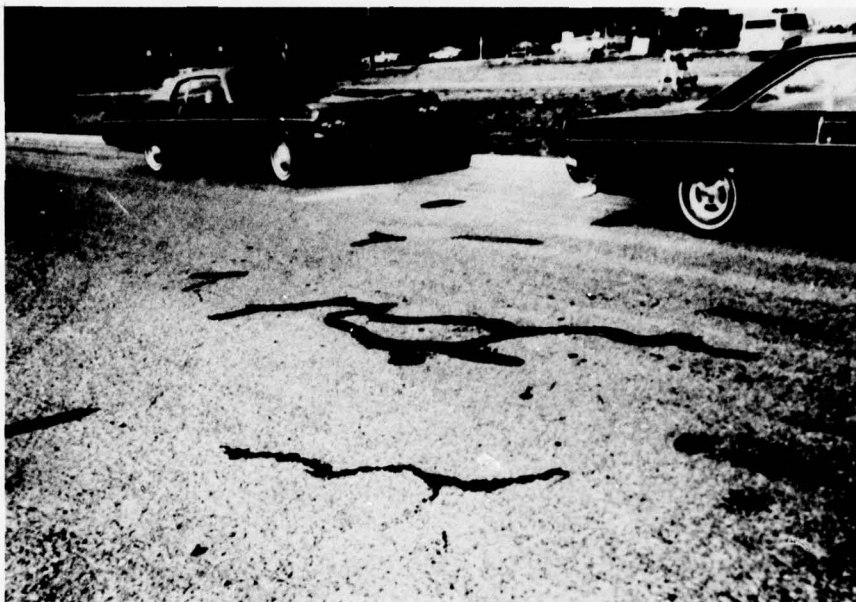
areas on Faith Avenue. All cracks had been sealed with AR-4000 asphalt on Faith Avenue on 4 October 1977 (Photo 33). The asphalt rubber was applied on Faith Avenue at a rate of about 0.6 gal/sq yd (Photo 34); then heated, uncoated chips were placed immediately after spray application at a rate of about 30 lb/sq yd (Photo 35). The joints were swept with a power broom prior to application of the next distributor lane (Photo 36). The air temperature during application of the Sahuaro material varied from the middle 40°F temperature in the morning to the high 50's in the afternoon with an overnight low of about 34°F.

Photo 33. Fort Lewis--cracks on Faith Avenue sealed with AR-4000 asphalt

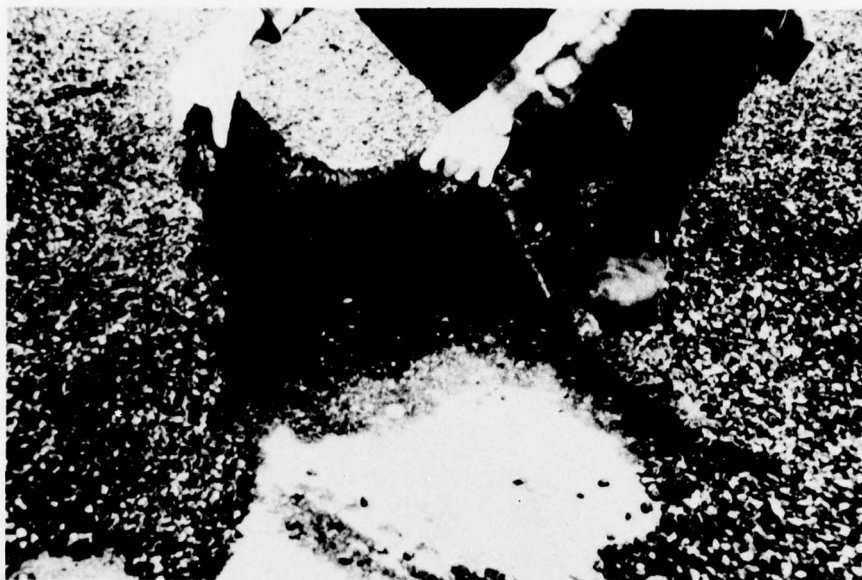
Photo 37. Fort Lewis--asphalt-rubber membrane  
peeled up due to wet pavement surface

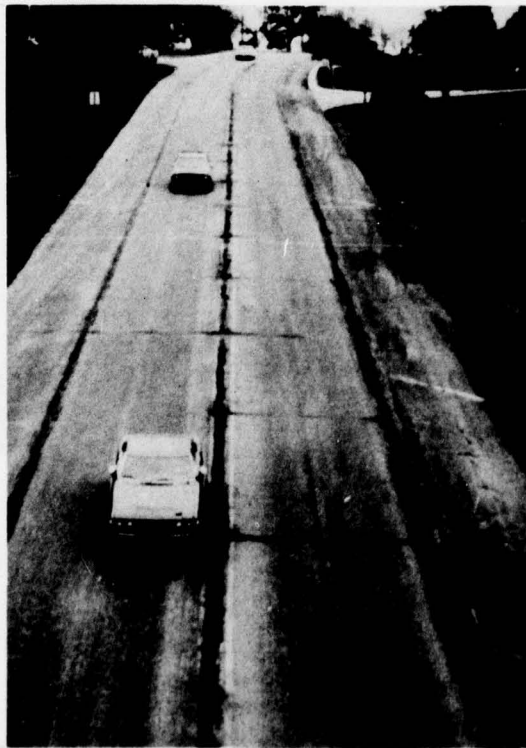
34. Louisiana Avenue, which is the entrance road for Fort Polk through Gate No. 1, was constructed of 6-in. jointed portland cement concrete (JC). The date of original construction is not known. The JC pavement was overlaid in 1962 with 2 in. of asphaltic concrete. The joints in the JC pavement have reflected through the asphaltic overlay (Photo 40). There is some cracking in the asphaltic concrete shoulder pavements. The work under this contract consisted of cleaning and sealing the cracks caused by the underlying JC pavement joints and placement of Petromat fabric over the 24-ft roadway and the shoulders. The fabric was placed on the pavement from the entrance gate to Georgia Avenue (Figure 4), and this area received a 1-1/2-in.-thick asphaltic concrete overlay. From Georgia Avenue to Texas Avenue, a 2-in.-thick asphaltic concrete overlay was placed without fabric. The shoulders were overlaid with a 1-in.-thick, open-textured asphaltic concrete from the entrance gate to Georgia Avenue and a 1/2-in. thickness of open-textured asphaltic concrete from Georgia Avenue to Texas Avenue. The fabric and overlay were placed on the main roadway in December 1977, and the shoulder pavements and fabric were placed in January 1978.

Photo 40. Fort Polk--joints from underlying PCC reflected through AC overlay

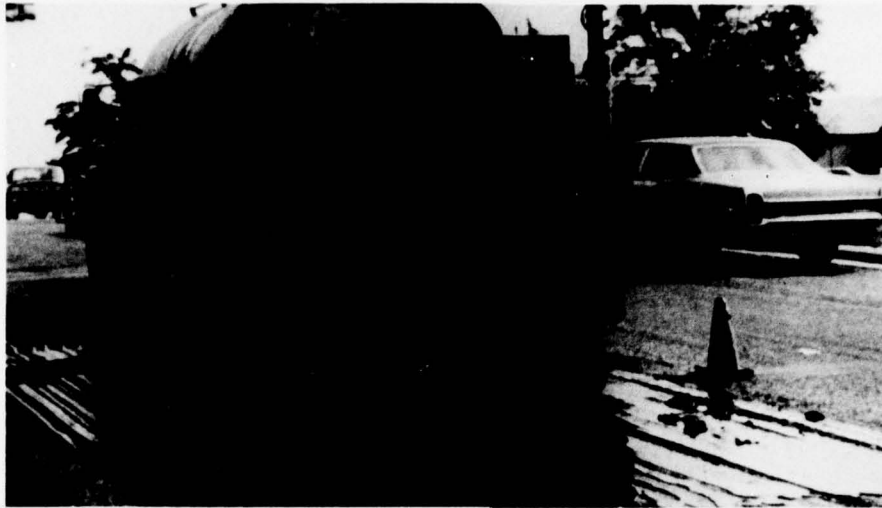
36. The weather was quite cool and wet during the period of work on Louisiana Avenue. The asphalt tack material used for placement of the Petromat fabric was AC-20 paving grade asphalt. Approximately 0.25-gal/sq-yd tack was to be placed prior to placement of fabric, but as shown in Photo 41, the asphalt distributor did not spray a uniform tack coat as specified. The fabric was placed with a small tractor, equipped with special attachments to lay fabric (Photo 42). The tractor operator was inexperienced in this work and did not lay a wrinkle-free

Photo 41. Fort Polk--spraying of tack for fabric  
very poor; nonuniform spray application

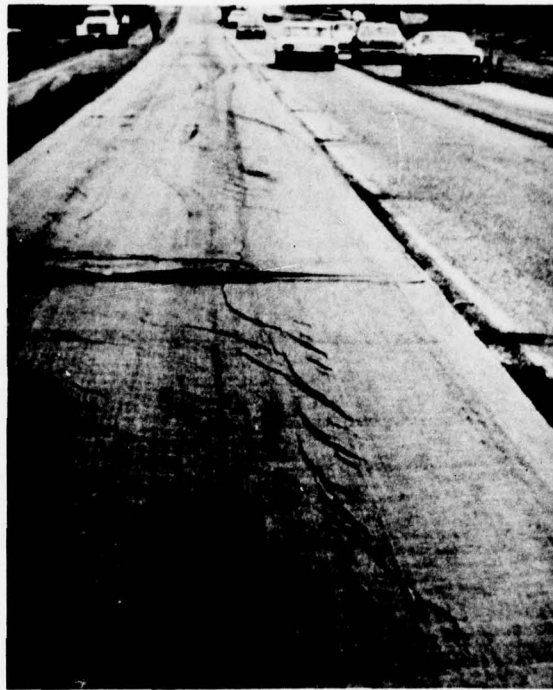
fabric (Photo 43). No problems were reported in the placement of the overlay over the fabric.

Photo 43. Fort Polk--Petromat fabric placed with considerable amount of wrinkles

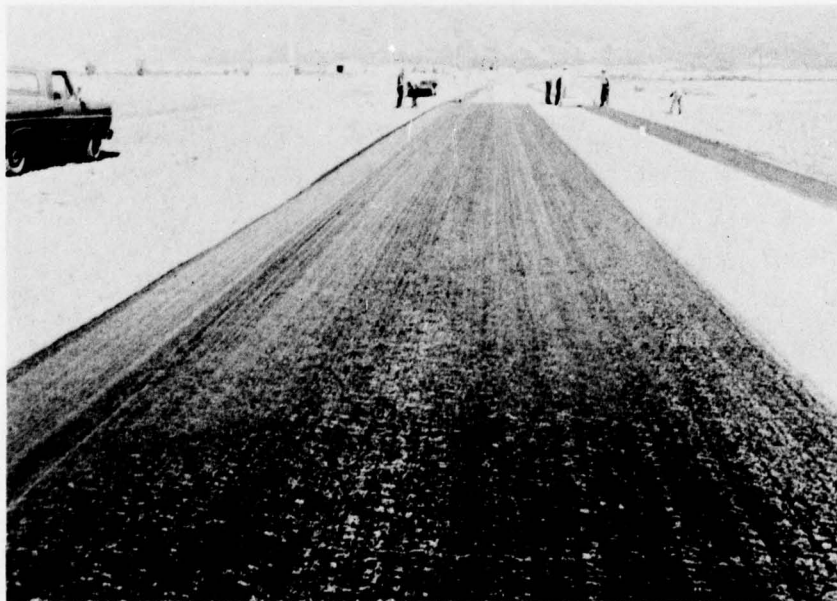
41. Arizona Refining Company used their distributor truck to spray the AC-10 tack material for the fabric test sections. The AC-10 was obtained from Continental Oil Company in Denver. Initial spray of tack for the first lane of the Bidim C-22 fabric resulted in only about 0.15 gal/sq yd of material placed when about 0.22 gal/sq yd was required (Photo 44). This was because the AC-10 was not hot enough to spray properly. The material was heated to about 310°F and reapplied. Total amount of tack material for the first lane of Bidim C-22 was about 0.30 gal/sq yd. The rate of application was controlled much better after the material was heated to the higher temperature. The Bidim C-22 fabric was received in rolls 200 ft long and 13 ft 10 in. wide and was placed by two men holding a 1-in. pipe suspended through the core of the roll and unrolling the fabric in the fresh tack material (Photo 45). A longitudinal lap joint of about 6 in. was used at the center of the roadway, and the excess fabric was cut along each edge of the roadway. The Mirafi 140 fabric was placed next. The fabric, which was in a roll 328 ft long and 14 ft 9 in. wide, was first sawed to a width so that two lanes would have 24 ft 6 in (Photo 46). The test area was sprayed with asphalt tack at the rate of 0.18 gal/sq yd. Fabric laydown was accomplished by attaching a 1-in.-diam support pipe and hand-held brake devices to the fabric roll and adjusting each brake to provide uniform drag. The fabric was then placed by unrolling about 20 ft of fabric, stretching it taut and

Photo 44. Fort Carson--application of tack very light, about 0.15 gal/sq yd

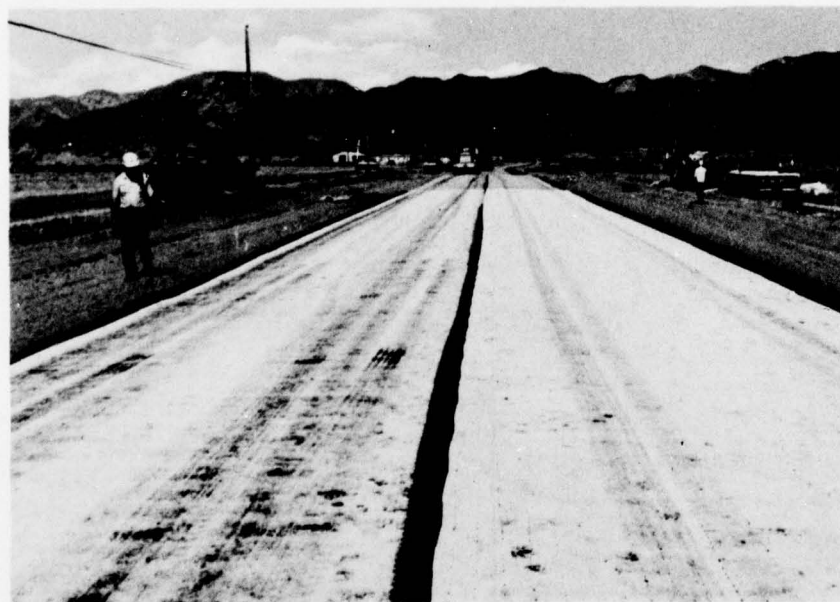
wrinkle free, and lowering it into the asphalt (Photo 47). All spray applications were begun and ended on building paper (Photo 48). The Petromat (Paving-Grade fabric weighing 4.2 oz/sq yd) was placed next. Phillip's Fibers Corporation also manufactures a 6- and 8-oz Paving-Grade Petromat fabric. The fabric was in a roll 300 ft long and 12 ft 6 in. wide and was placed with a small tractor designed and equipped to lay fabric (Photo 49). The test area was sprayed with asphalt tack at the same rate as had been applied for the Bidim C-22 fabric (between 0.2 and 0.25 gal/sq yd). The tractor is positioned with the roll of fabric on the front and proceeds to lay the fabric in the fresh tack material fairly rapidly (Photo 50). The fabric can be laid fairly wrinkle free with an experienced operator on the tractor (Photo 51). Placement of all fabric sections was completed by early afternoon. There was some excess Petromat fabric, and this was placed in the area indicated in Figure 5 between telephone poles Nos. 1 and 2. All fabric areas were rolled with a pneumatic-tired roller after completion; and with the high air temperatures, the asphalt tack was evident on the surface of the fabric (Photo 52).

Photo 52. Fort Carson--tack material evident on surface of fabric

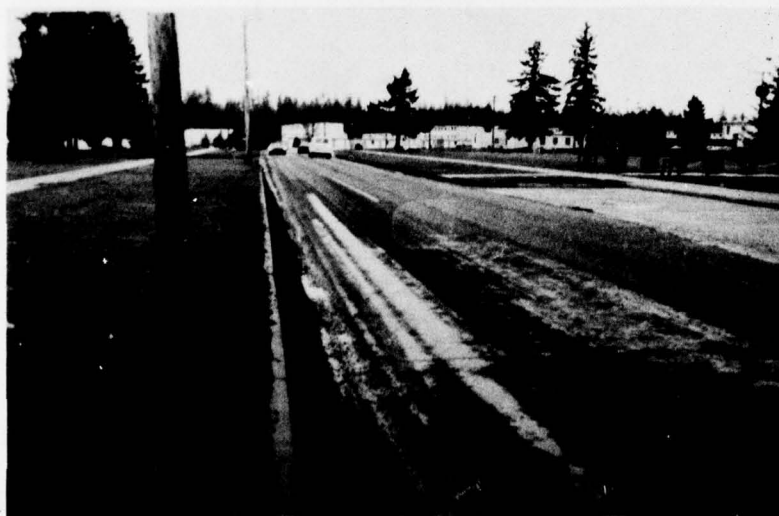
44. In February 1978, approximately 5 months after construction, it was reported by personnel of the Facilities Engineering that distress in the form of ravelling was occurring in the asphalt-rubber chip seal on Second Division Drive, and fine hairline cracks were observed in one of the fabric sections on Faith Avenue. A visit was made to Fort Lewis at that time, and it was found that the asphalt-rubber chip seal placed by Sahuaro on Second Division Drive was ravelling with loss of chips in the traffic wheel paths and turnoffs to parking areas (Photo 58).

Ravelling was occurring in areas where the precoated chips and uncoated chips were used and was worst in the wheel path of vehicles travelling south. A considerable buildup of loose chips was evident at the curb line. The U. S. Rubber chip seal was observed to have an area about 100 ft long along the center line of the roadway where during construction the distributor truck failed to overlap the first spray application and a blank area about 6 in. wide existed (Photo 59). On the south side of Faith Avenue at the transition area between the Mirafi 140 fabric section and the U. S. Rubber section, a crack had developed and fabric was protruding up through the overlay (Photo 60). A core taken in this area indicated that loose cover aggregate from the U. S. Rubber section was not cleaned off the pavement prior to placement of the fabric and the aggregate kept the fabric from bonding to the pavement. A fine hairline crack was found about midway in the Mirafi 140 fabric section on the south side of Faith Avenue and also one on the north side (Photo 61). Cores taken indicated the fine hairline crack was a result of a wrinkle in the fabric and not reflection from a crack in the base pavement.

Photo 58. Fort Lewis--asphalt-rubber chip seal placed  
by Sahuaro raveling in traffic wheel paths;  
note buildup of loose chips at curb line

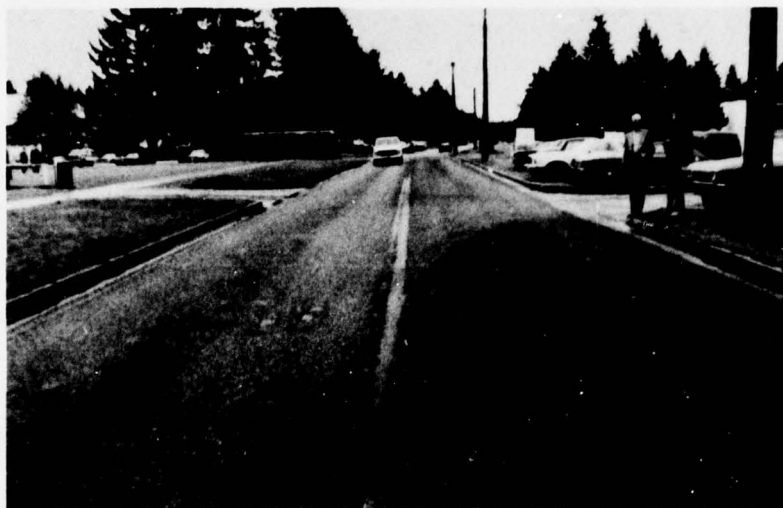
Photo 59. Fort Lewis--U. S. Rubber chip seal with bare spot  
at center line; area did not receive rubberized  
material during construction

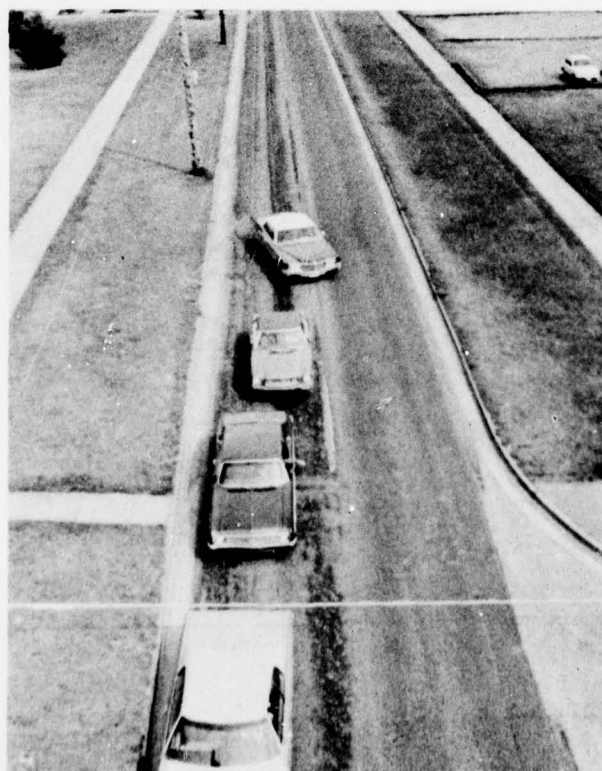
Photo 63. Fort Lewis--reflection crack in control  
section on north side of Faith Avenue

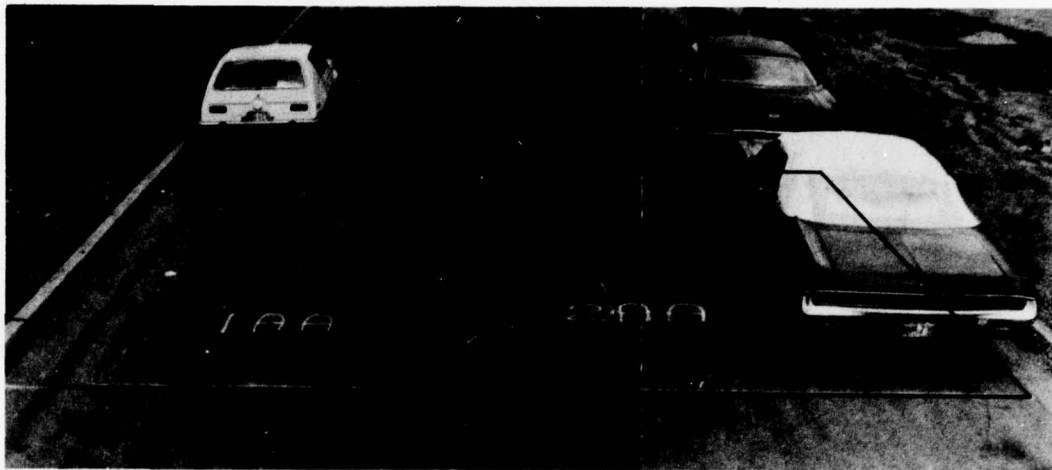
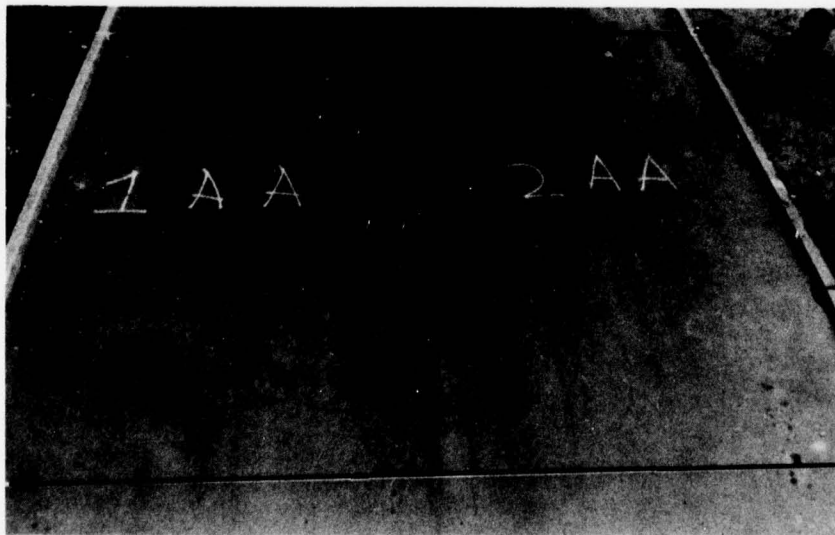
Photo 64. Fort Lewis--Bidim C-22 fabric section,  
south side of Faith Avenue

b. Condition of surface 6 months after overlay

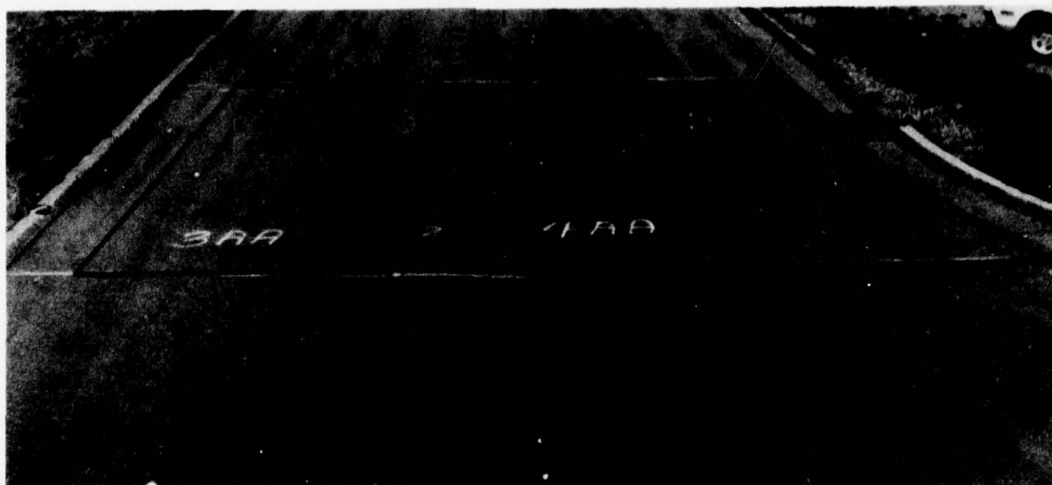
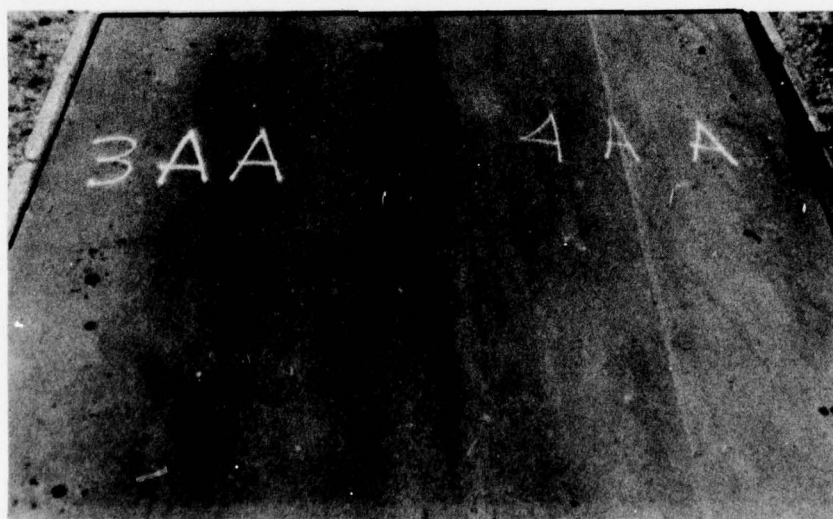
Photo 65. Fort Lewis--Sahuaro rubber section,  
south side of Faith Avenue

b. Condition of surface 6 months after overlay

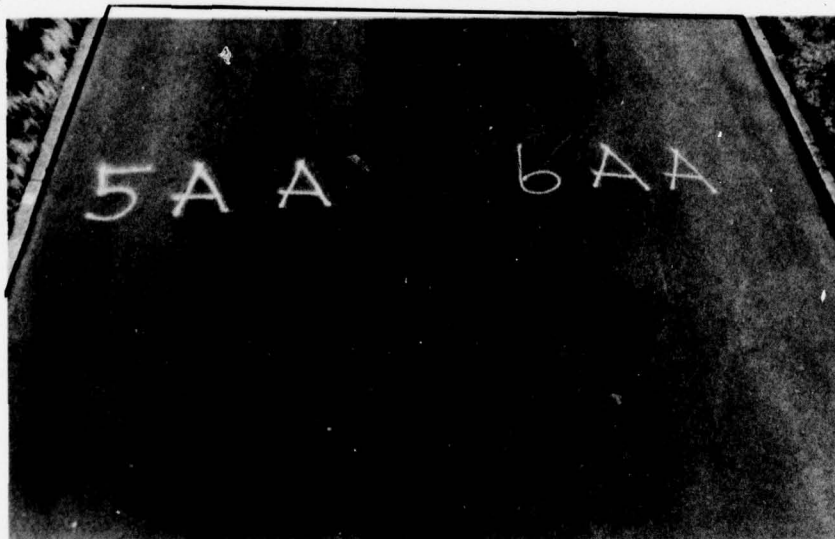
Photo 66. Fort Lewis--control section,  
south side of Faith Avenue

b. Condition of surface 6 months after overlay

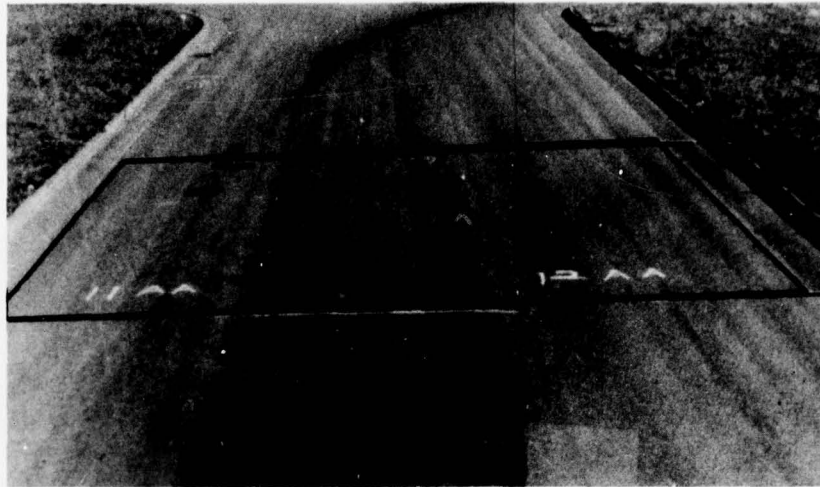
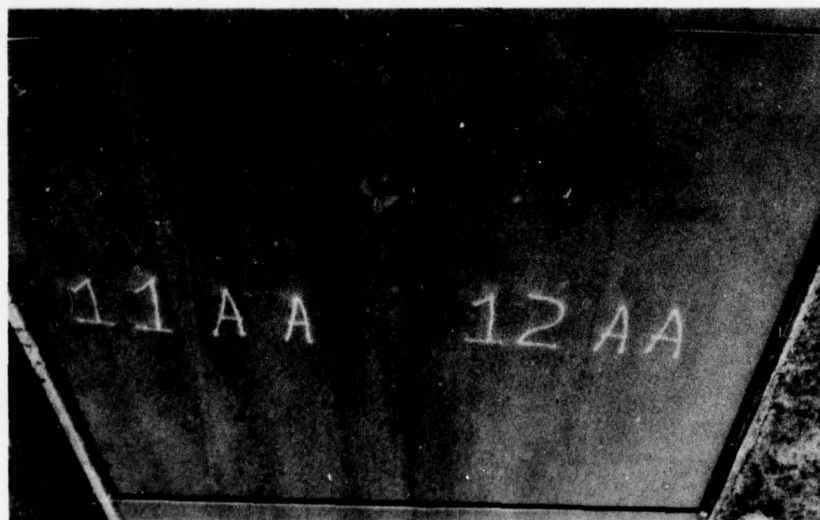
Photo 69. Fort Lewis--Sahuaro rubber section;  
north side of Faith Avenue

b. Condition of surface 6 months after overlay

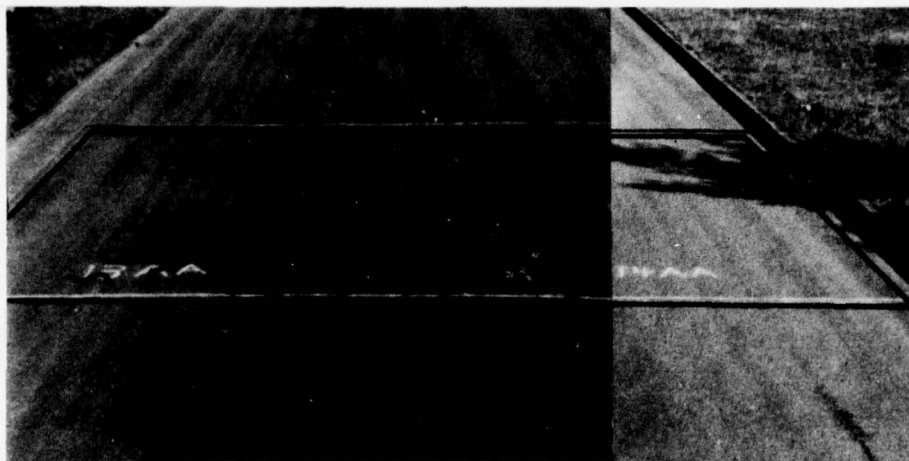
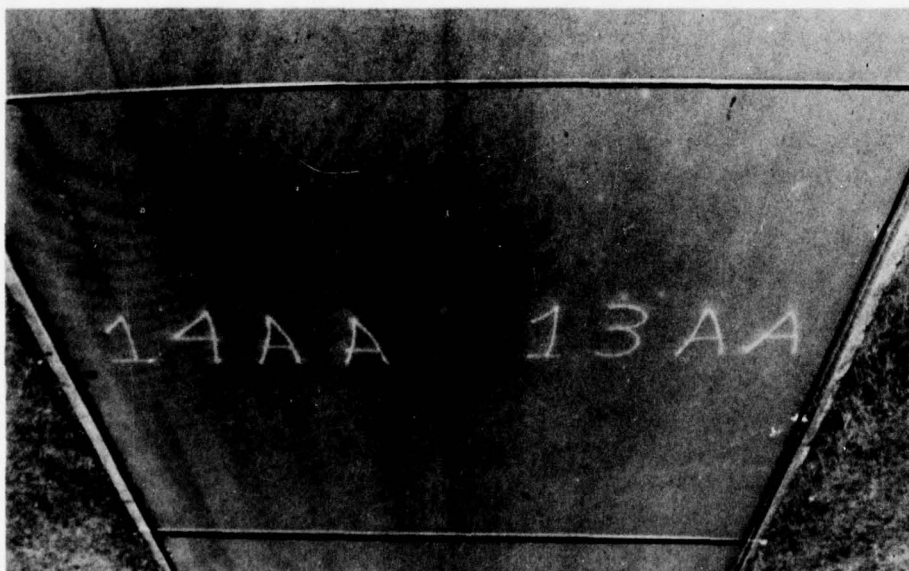
Photo 70. Fort Lewis--Mirafi 140 fabric section;  
north side of Faith Avenue

b. Condition of surface 6 months after overlay

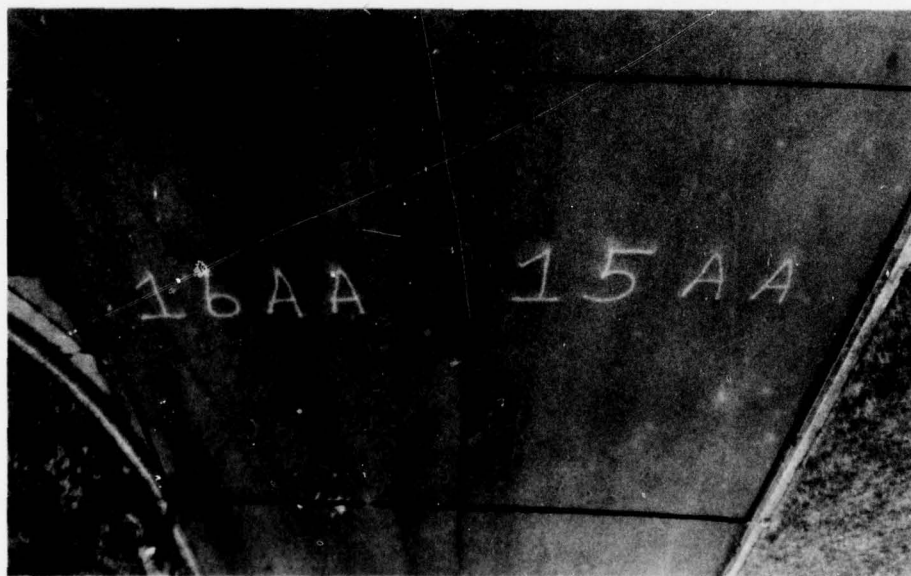
a. Condition of surface prior to overlay

b. Condition of surface 6 months after overlay

Photo 71. Fort Lewis--control section,  
north side of Faith Avenue

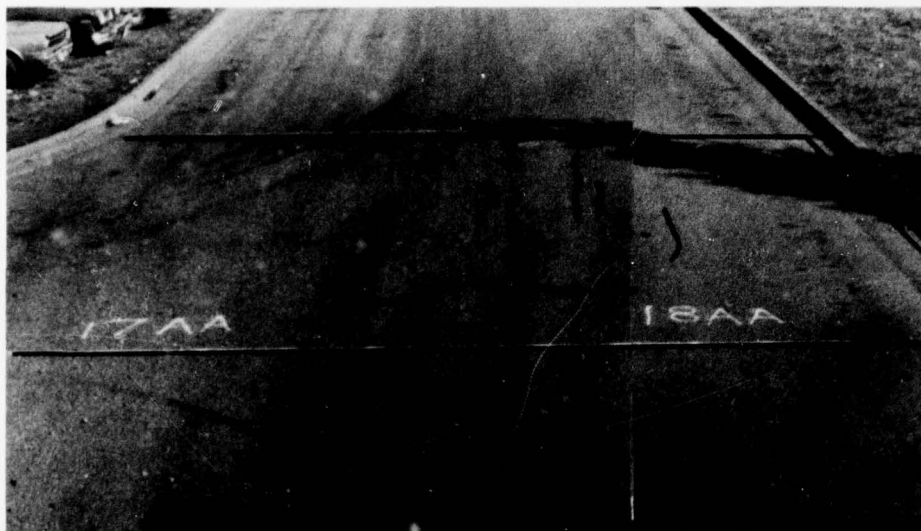
a. Condition of surface prior to overlay

Photo 72. Fort Lewis--Bidim C-22 fabric section;  
north side of Faith Avenue

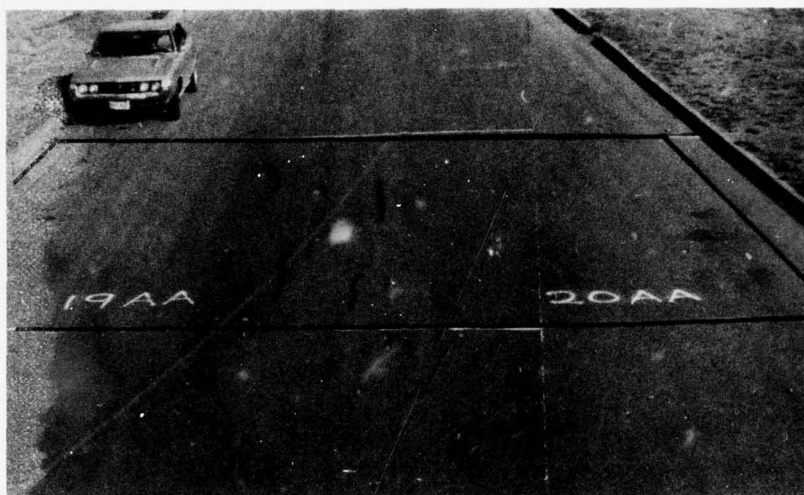
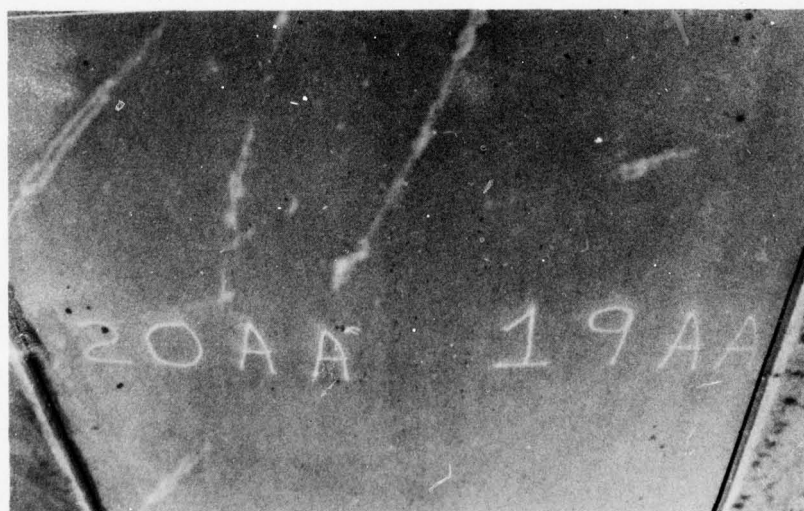
a. Condition of surface prior to overlay

b. Condition of surface 6 months after overlay

Photo 73. Fort Lewis--U. S. Rubber section,  
north side of Faith Avenue

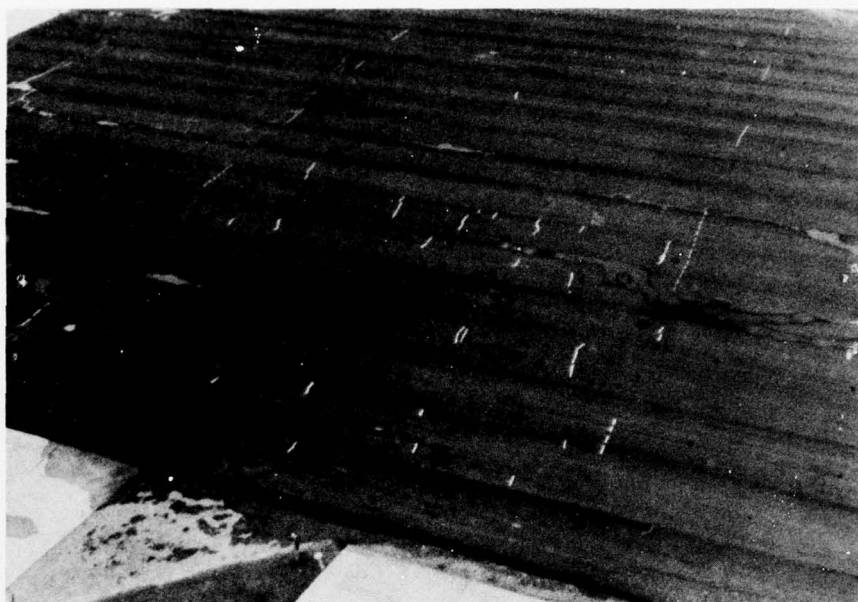
46. The overlay was placed on the apron at Fort Stewart on 28 October 1977 and on 31 October 1977. It was reported that after placement of the overlay cracks were observed to have occurred in the Mirafi 140 fabric test area. A visit was made to Fort Stewart on 3 November 1977 to check on the cracking that had occurred. All cracks were observed to be perpendicular to the paving and rolling operations (Photo 77). Cores taken in a number of the cracks indicated that they were the result of reflection from cracks in the underlying pavement; however, the fabric was creased in the crack and was not broken. No cracks were observed in any of the other test sections.

Photo 77. Fort Stewart--cracks in Mirafi 140 section  
that occurred during construction are outlined with chalk;  
dashed lines indicate limits of section

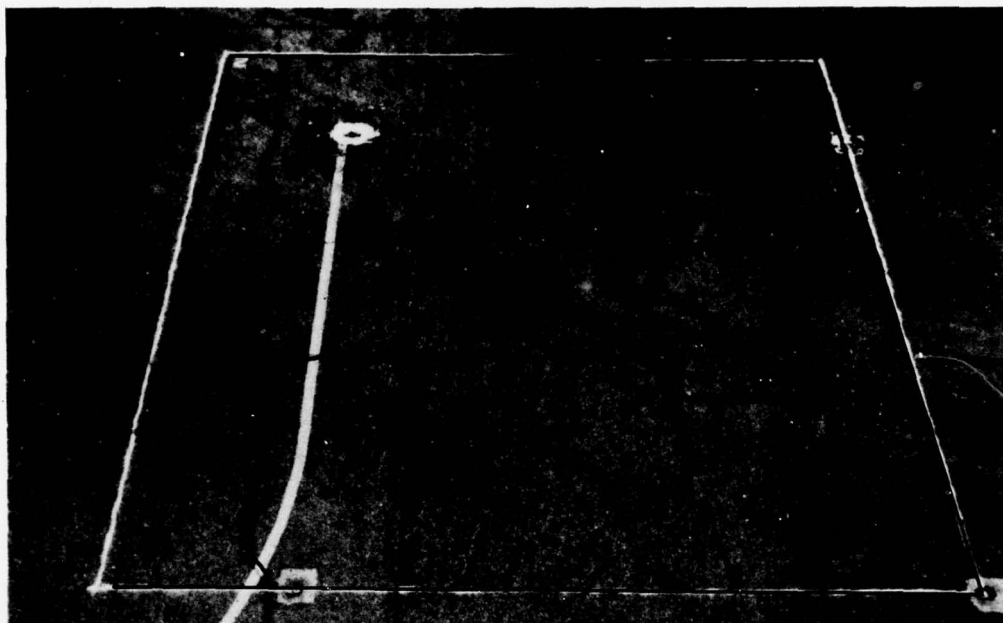
a. Condition of surface prior to overlay

b. Condition of surface 6 months after overlay

Photo 80. Fort Stewart--test square in north end  
end of Sahuaro rubber section

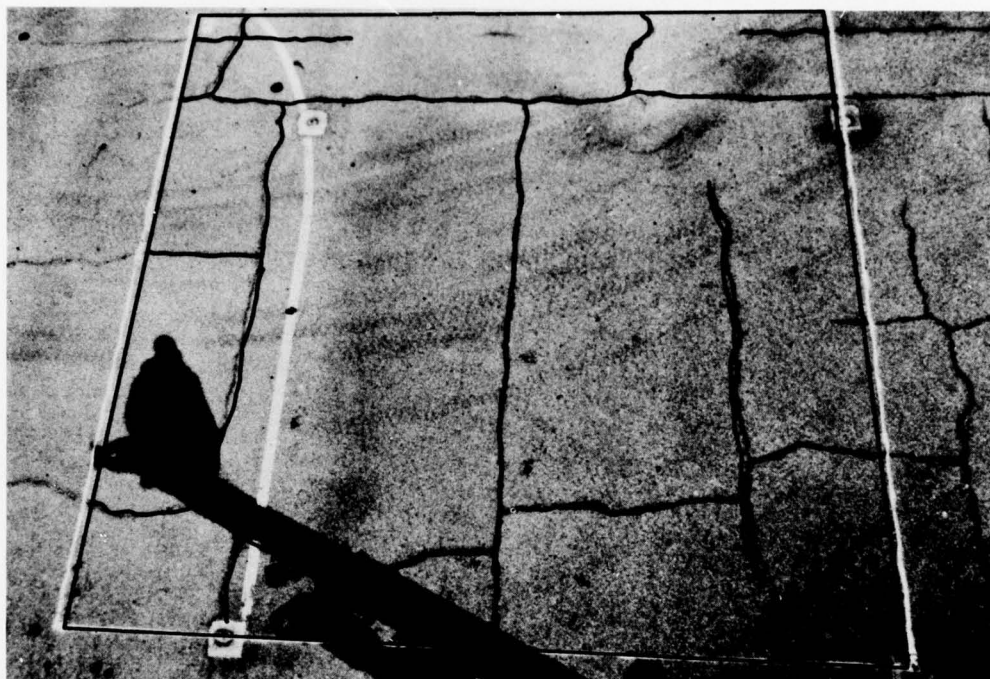
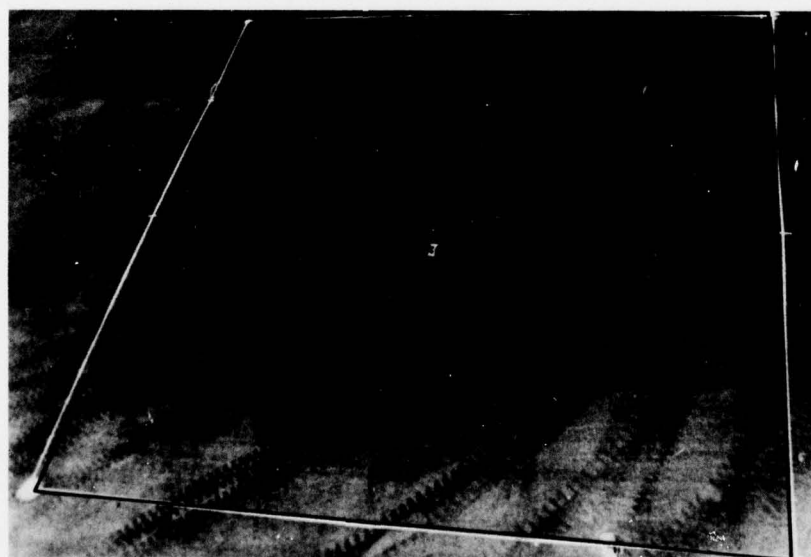
a. Condition of surface prior to overlay

b. Condition of surface 6 months after overlay

Photo 81. Fort Stewart--test square in south end  
of U. S. Rubber section

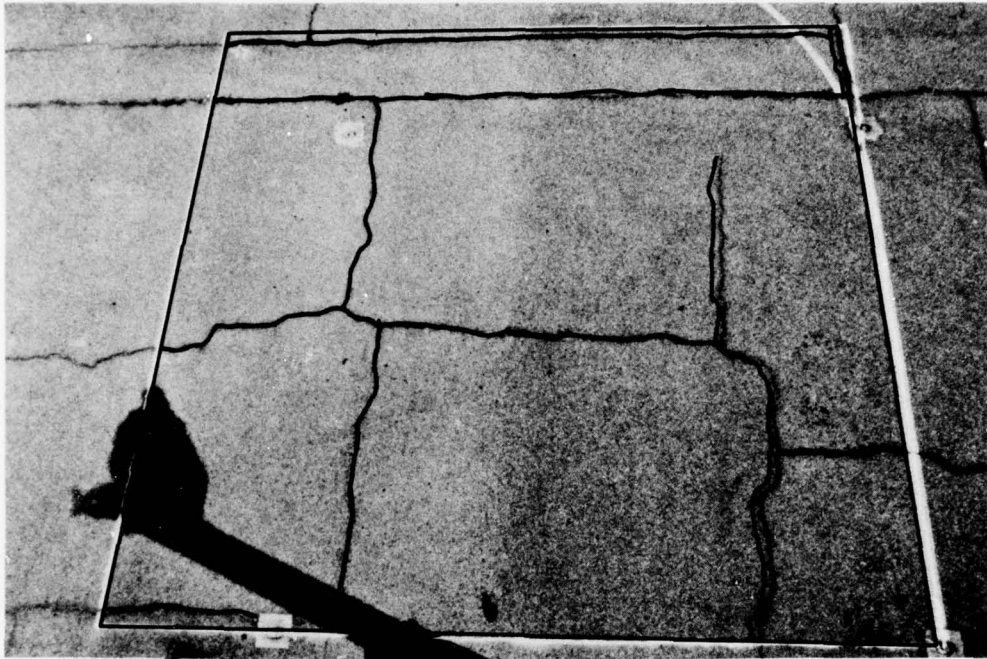
a. Condition of surface prior to overlay

b. Condition of surface 6 months after overlay

Photo 82. Fort Stewart--test square in north end  
of U. S. Rubber section

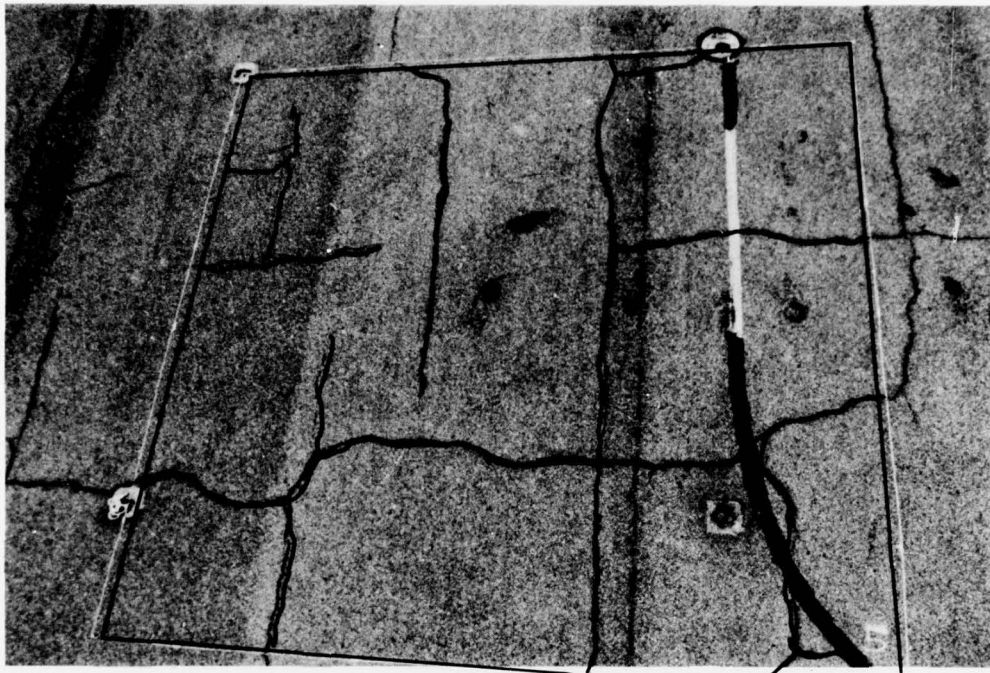
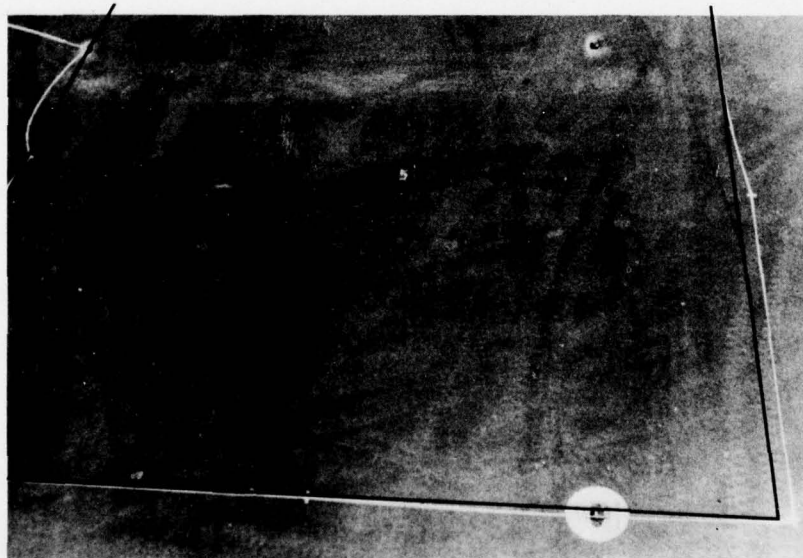
a. Condition of surface prior to overlay

b. Condition of surface 6 months after overlay

Photo 83. Fort Stewart--test square in north end  
of Bidim C-22 fabric section

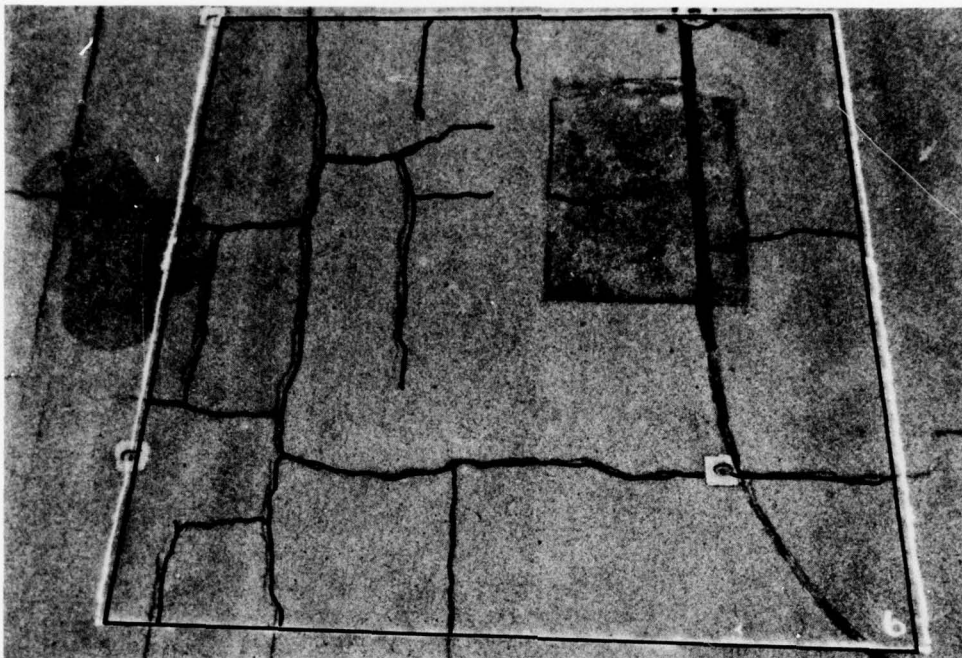
a. Condition of surface prior to overlay

b. Condition of surface 6 months after overlay

Photo 84. Fort Stewart--test square in south end  
of Bidim C-22 fabric section
